Manhole Inspection Summary

Manhole # S03CC2001MH

Insp Date: **10/3/06 1:32 PM**

Location Address: **6204 CROSS COUNTRY BLVD** Cross Street: **PINKNEY RD**

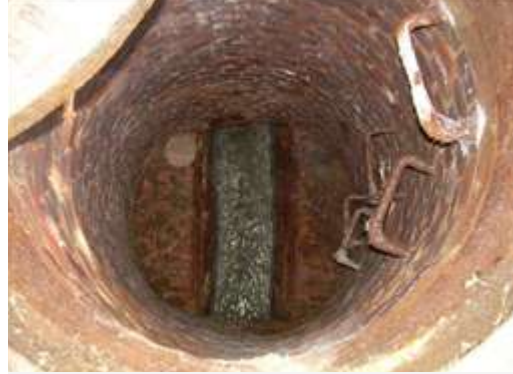
Top View

Frame leaks. Adjustment infiltration.
Corroded steps. Bench debris.

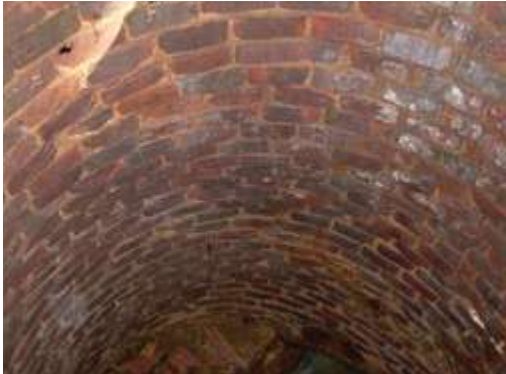
Defect

Corbel and Barrel root intrusion. Barrel infiltration.

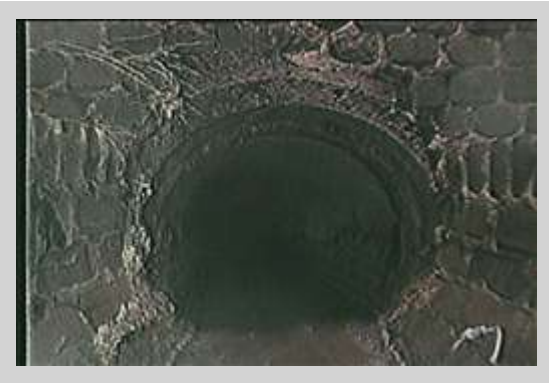
21 in. Circular Gravity Sewer Pipe Out @ 12 O'Clock

Comments **Both of the pipe pictures show Barrel deterioration; Barrel, Bench, and Channel root intrusion. The O12 pipe picture also shows grease deposits in the Channel.**

Infiltration: **Evidence** Pipe Seal Cond: **Roots**

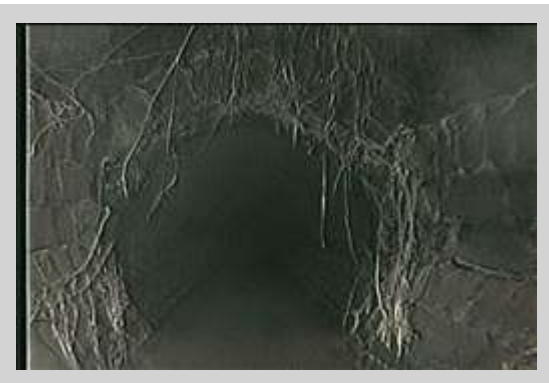
21 in. Circular Gravity Sewer Pipe In @ 6 O'Clock

Infiltration: **Evidence** Pipe Seal Cond: **Roots**
